# US 62 and Harmont Avenue Intersection Safety Improvement Study

Safety Study  
Prepared for: Stark County Area Transportation Study  
August 2024

Stark County Area Transportation Study  
Stark County, Ohio  
Intersection: US Route 62 and Harmont Avenue  
Study Completion Date: July 2024  
Consultant: Environmental Design Group

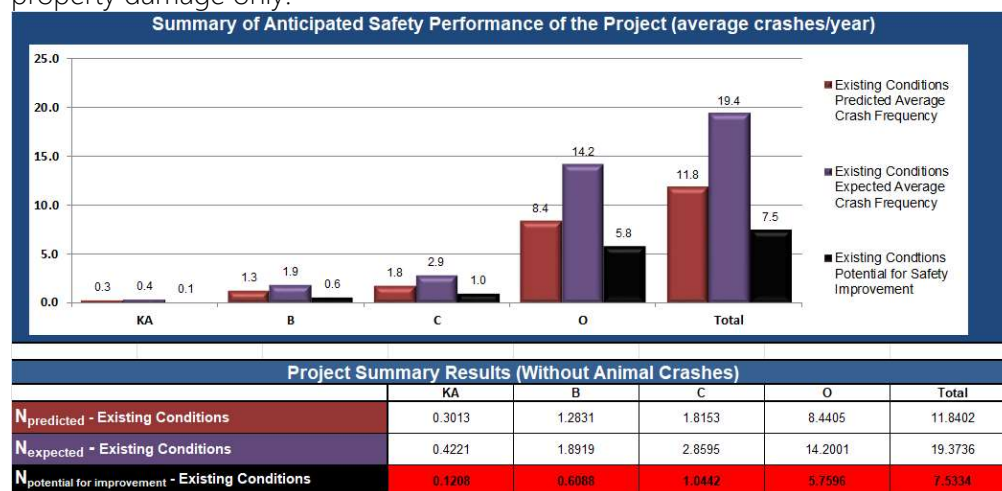
Figure 27 - ECAT summary of potential safety improvements

In the case of US 62 and Harmont Avenue, the model provides an estimated Predicted Average Crash Frequency of 11.8 crashes per year and an estimated Expected Average Crash Frequency of 19.4 crashes per year for the existing conditions. The frequency of crashes estimated for the intersection is 7.5 crashes per year more than what the HSM model predicts it should be experiencing. Therefore, the calculated potential for safety improvements (predicted frequency

minus expected frequency) is a positive value, 7.5, as shown in the far right column of Figure 27.

Therefore, this intersection is believed to have a positive potential for safety improvement and this study recommends the appropriate countermeasures to achieve it.

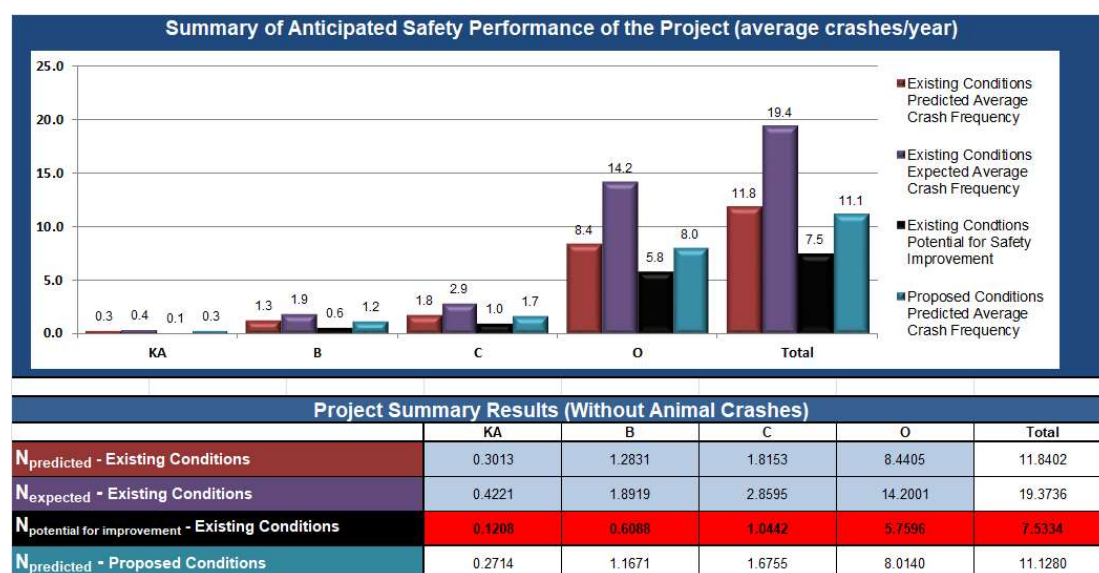
**Figure 28 - ECAT Analysis Report for Alternative 1: Pedestrian Improvements and New Edge Lines**

By implementing all the changes presented in Alternative 1, the Predicted Average Crash Frequency decreases to 11.1 crashes per year. This represents a 43% improvement from the Existing Expected Average Crash Frequency and a 6% improvement from the Existing Predicted Average Crash Frequency. See **Figure 28** below to view these values.

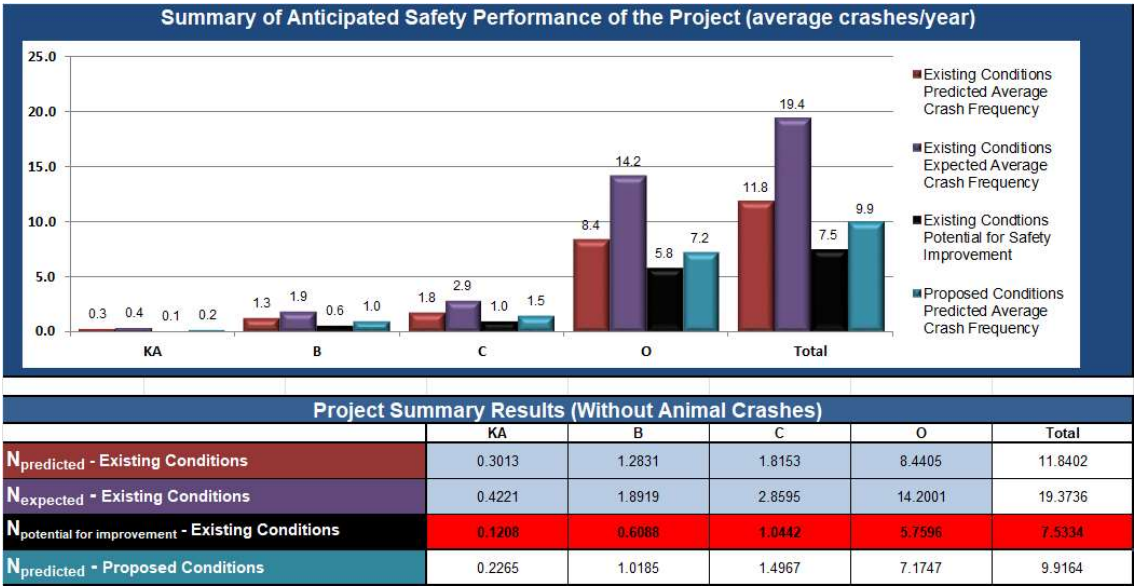
Figure 29 - ECAT Analysis Report for Alternative 2: Reduction of Access Points

By implementing all the changes presented in Alternative 2, the Predicted Average Crash Frequency decreases to 9.9 crashes per year. This represents a 49% improvement from the Existing Expected Average Crash Frequency and a 16% improvement from the Existing Predicted Average Crash Frequency. See Figure 29 below to view these values.

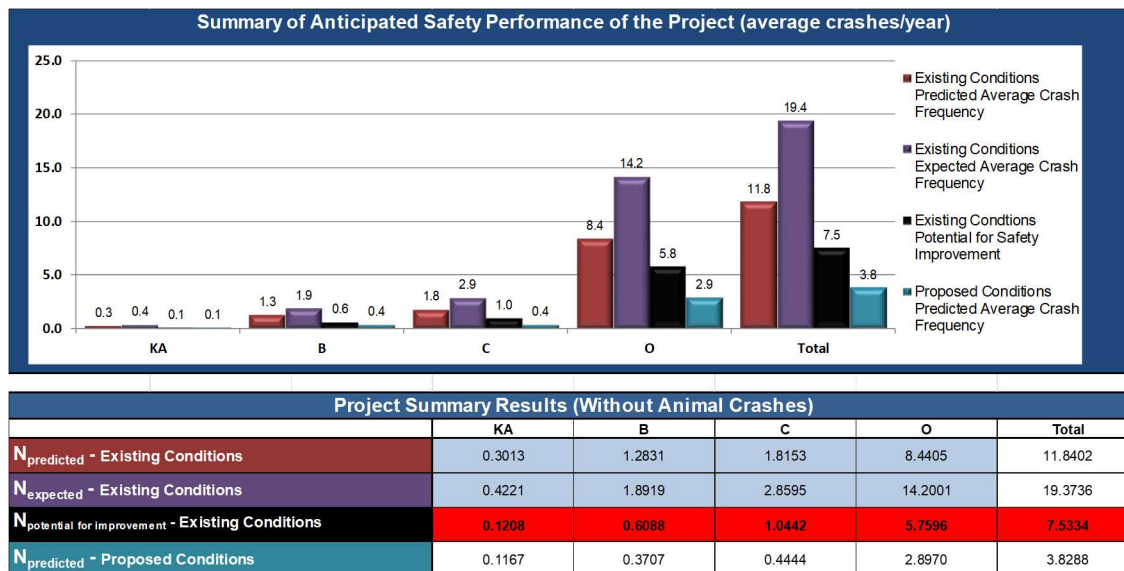
Figure 30 - ECAT Analysis Report for Alternative 3: Limited Access Interchange

By implementing the changes listed in Alternative 3, the Predicted Average Crash Frequency calculated in ECAT decreases to 3.8 crashes per year. This represents an 80% improvement from the Existing Expected Average Crash Frequency and a 68% improvement from the Existing Predicted Average Crash Frequency. See **Figure 30** to view these values.
